### 2020 INDEPENDENT HIP STUDY

# Improve Creep Rupture Properties of Engine Run, Fr7FA.03, 1st Stage Buckets.

BY WARREN MIGLIETTI, PH.D., FALL 2020

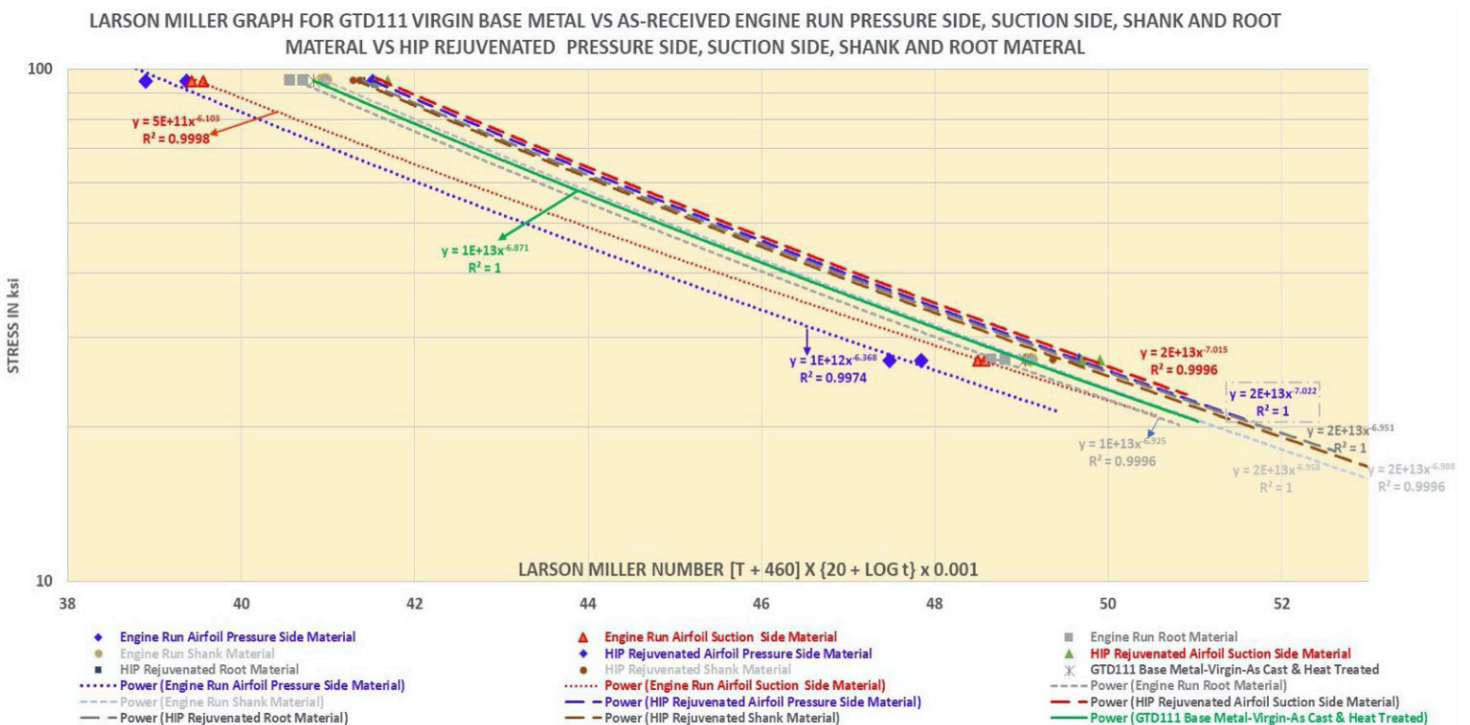
**FIGURE 1**

**FIGURE 1:** (below) Shows the same tabular data in Table 1 in graphical form. What is clear is that all HIP Rejuvenated material represented by the 4 dashed lines (not dotted lines) essentially lie on top of each other, showing that the HIP Rejuvenation process reduced scatter in the data. R squared values of 1 were recorded 4 times. The other crystal clear information shown in Figure 1 is that the HIP Rejuvenated material even had better stress rupture properties compared to that of the virgin like base metal, proving that HIP Rejuvenated material has superior stress rupture properties when compared to original cast and heat treated material. The 2 dotted lines show the engine run pressure and suction side of the airfoil material, indicating that engine run material declines in strength and creep properties as a result of engine exposure.

The first stage bucket in Figure 1 operates for 2 or 3 service intervals depending on whether the engine operates in base load or cyclic mode. Table 1 shows how after 2 service intervals the airfoil material, GTD111TM has degraded such that it is significantly below the as-cast virgin like stress rupture properties.

As can be seen in Table 1, the engine run material removed from the airfoil and root all failed below 50 hours when stress rupture tested at 1800°F/27ksi; whereas the 2 specimens removed from the shank barely passed achieving 51.4 and 54.3 hours respectively. However, all the HIP Rejuvenated material removed from the airfoil, shank and root successfully met the 50 hours minimum life. In fact, the HIP Rejuvenated material was 1.78X – 1.95X superior/better than virgin as cast and heat treated material at the stress rupture conditions of 1800°F/27ksi. A similar conclusion was reached at the 1400°F/95ksi condition, where the engine run material removed from the airfoil and root all failed below 100 hours; whereas the 2 specimens removed from the shank barely passed achieving 104.5 and 109.3 hours respectively. However, all the HIP Rejuvenated material removed from the airfoil, shank and root successfully met the 100 hours minimum life. In fact, the HIP Rejuvenated material was 1.76X – 2.20X superior/better than virgin as cast and heat treated material at the stress rupture conditions of 1400°F/95ksi. This first case study shows how the proper use of HIP Technology can be used to extend the life of these stage 1 buckets.
